**THE EFFECTS OF WINDBORNE DEBRIS
ON SAFEROOM WALL PANELS AND
FENESTRATION SYSTEMS**

**UNIVERSITY OF HAWAII
COLLEGE OF ENGINEERING**

Research Report UHM/CEE/12-10

February 2012

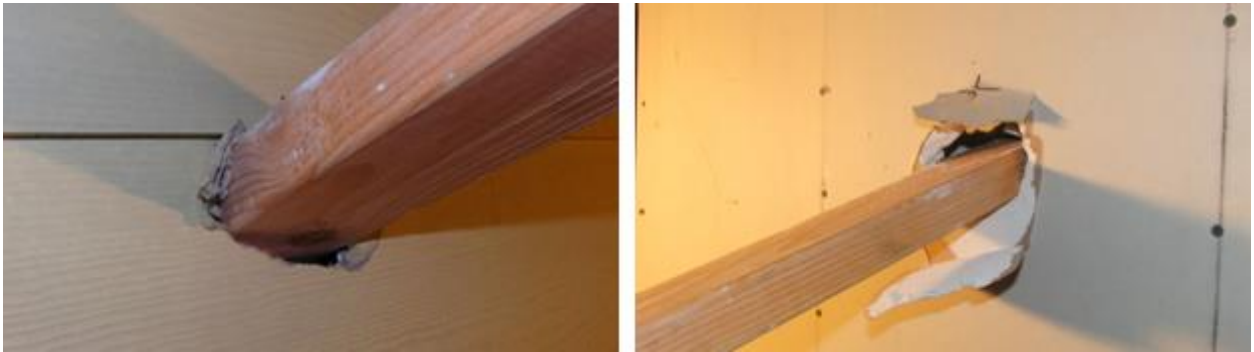
Figure 4-2: Panel O Typical Front (Left) and Rear (Right) Damage

This wall specimen served as the control sample for the HLP 4'x8' panels as it represents typical residential exterior wall construction. The exploded view of the wall, and all similar figures, indicate the wall layers in the order in which they will be struck by the missile (Figure 4-1). The large missile perforated the lap siding, HomeWrap and drywall of Panel O with little resistance (Figure 4-2). Panel O is considered a failure based on all three tests (Table 4-1).

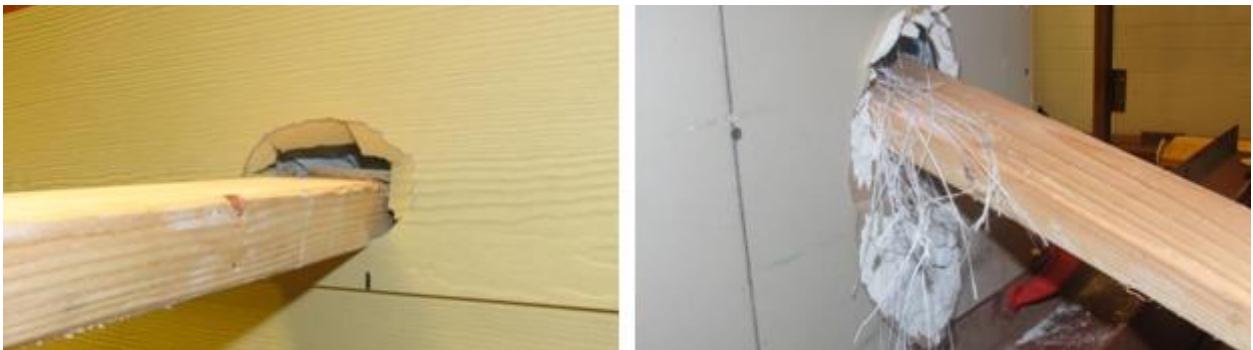
Figure 4-4: Panel A Typical Front (Left) and Rear (Right) Damage

This specimen was a derivative of the previous panel O with a layer of StormWrap replacing the HomeWrap behind the lap siding (Figure 4-3). It was constructed with the expectation that it would provide better resistance to impact forces. It did not prove effective at preventing missile perforation (Figure 4-4). Panel A is considered a failure based on all three tests (Table 4-2).

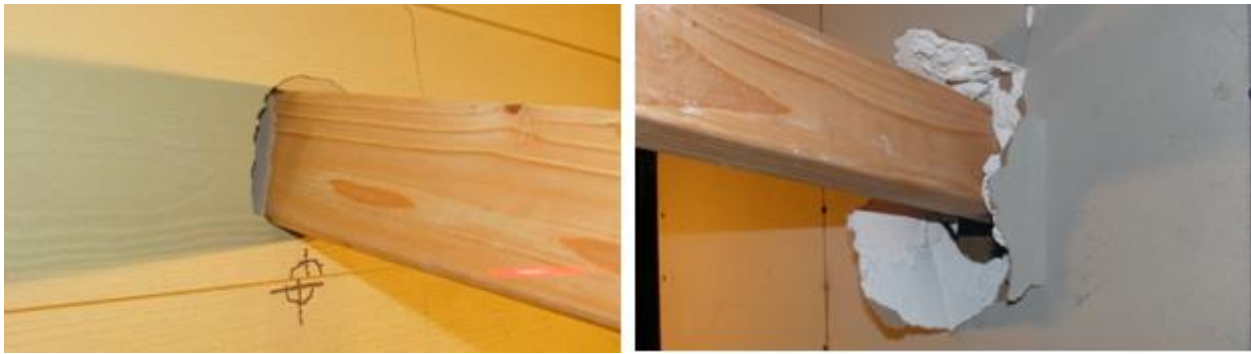
Figure 4-6: Panel B Front (Left) and Rear (Right) Damage for Bottom Left Test

This specimen is based on Panel O but with the addition of a 1/2in plywood sheet behind the HomeWrap (Figure 4-5). For the first two tests, the missile perforated all layers of the panel (Figure 4-6). On the third test, the missile penetrated the interior cladding and caused a 5in long split in the drywall, but not wide enough to be considered a failure. However, since two of the three tests resulted in perforation, the specimen was considered a failure (Table 4-3).

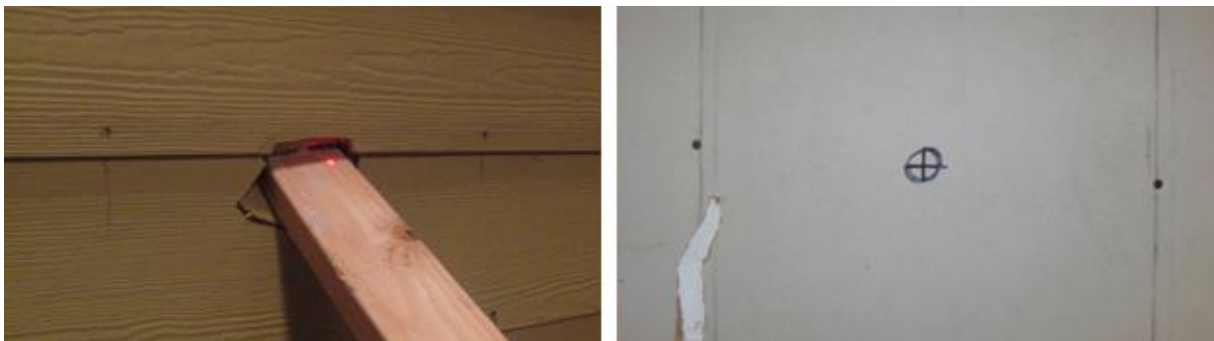
Figure 4-8: Panel C Front (Left) and Rear (Right) Damage for Three Passing Tests

This panel was identical to panel B but with a 5/8in plywood sheet replacing the 1/2in plywood (Figure 4-7). The first test caused a 10in long and 1in wide split in the drywall. This was considered a failed test, however, the remaining two tests were considered a pass as no damage was done to the interior drywall (Figure 4-8). A fourth test was implemented on a new panel to compare with the original failure. This final test was a pass, therefore, the panel was approved for class D large missile windborne debris impact resistance (Table 4-4).

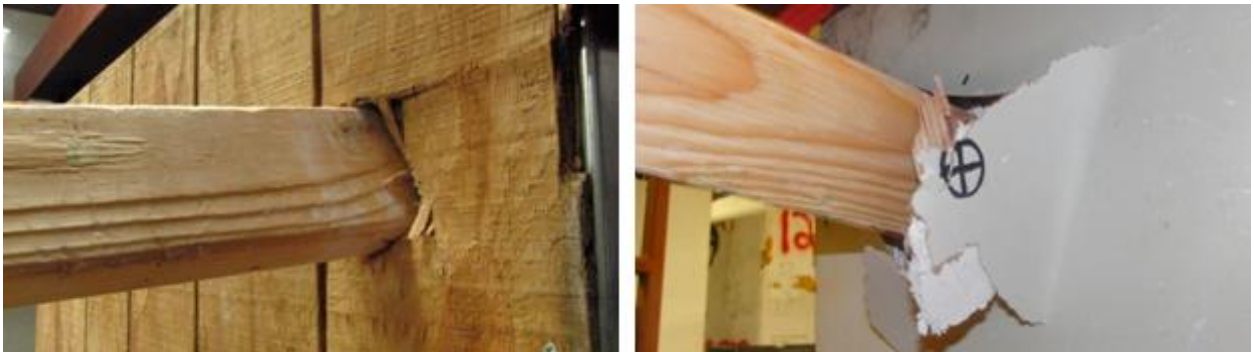
Figure 4-10: Panel O' Typical Front (Left) and Rear (Right) Damage

This wall specimen served as the control sample for the cold formed steel (CFS) 4'x8' panels (Figure 4-9). The large missile perforated the T1-11 exterior plywood and the drywall with little resistance (Figure 4-10). Panel O' is considered a failure based on all three tests (Table 4-5).

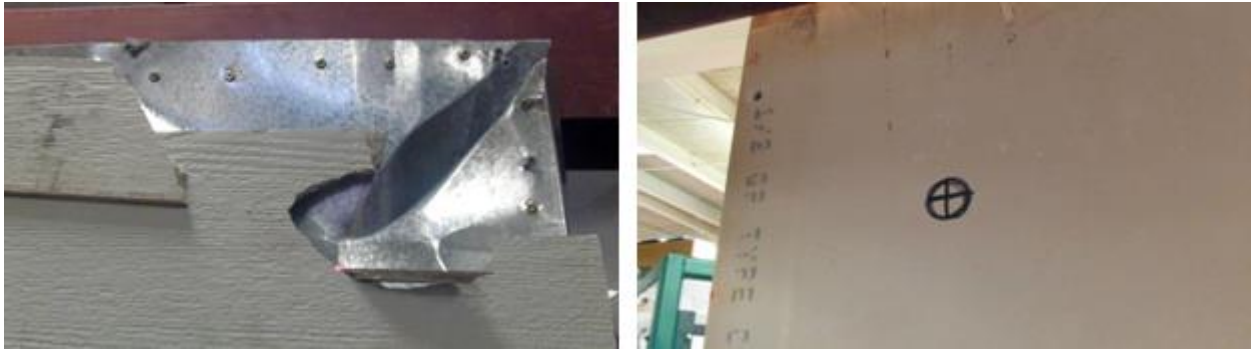
Figure 4-12: Panel G' Typical Front (Left) and Rear (Right) Damage

Panel G' consisted of exterior Hardie Board siding, a 22gauge sheet metal layer screwed to the exterior of CFS studs placed at 16in on center, and an interior drywall layer (Figure 4-11). The addition of the sheet metal panel behind the lap siding greatly improved the performance of the wall system. During corner strikes, the CFS studs buckled under the impact load but there was no damage to the drywall (Figure 4-12). All three test shots were regarded with passing results (Table 4-6).

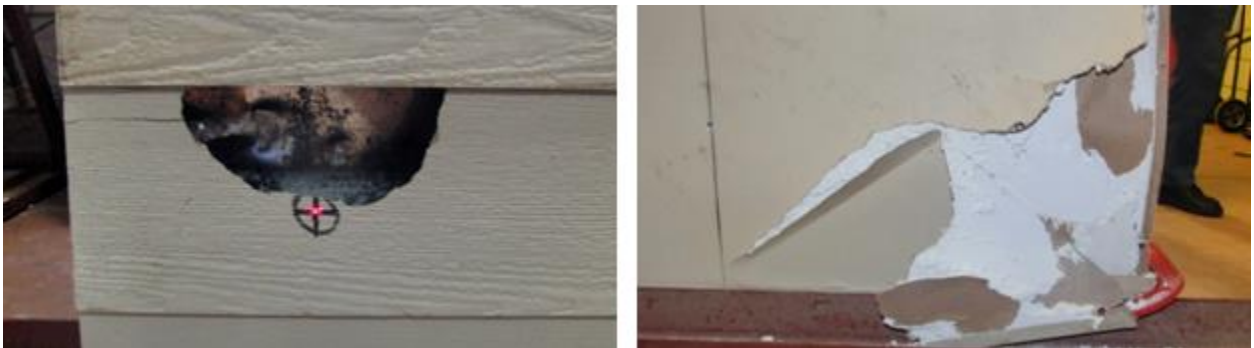
Figure 4-14: Panel H Typical Front (Left) and Rear (Right) Damage

This specimen is similar to Panel G' but with CFS studs at 24in on center instead of 16in. The 22 gauge sheet metal was also fastened behind the studs with self-taping screws (Figure 4-13). All three shots caused the drywall to delaminate (Figure 4-14). However, the missile did repurcuss from the sheet metal without perforating it. There was no tear in this layer of the panel so the specimen was considered a pass (Table 4-7).

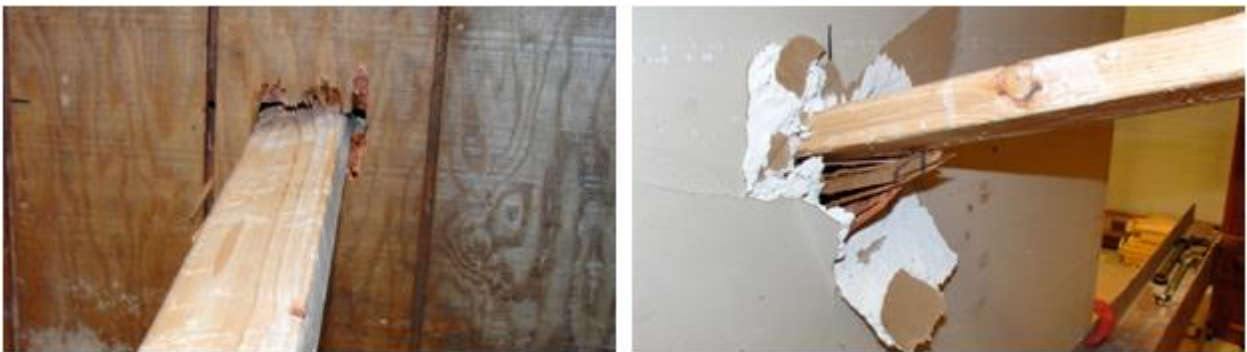
Figure 4-16: Panel Control M-O Typical Front (Left) and Rear (Right) Damage

This wall specimen served as the control sample for the CFS 4'x4' panels (Figure 4-15). The large missile perforated the T1-11 plywood and drywall with little resistance (Figure 4-16). Panel M-O is considered a failure based on all three tests (Table 4-8).

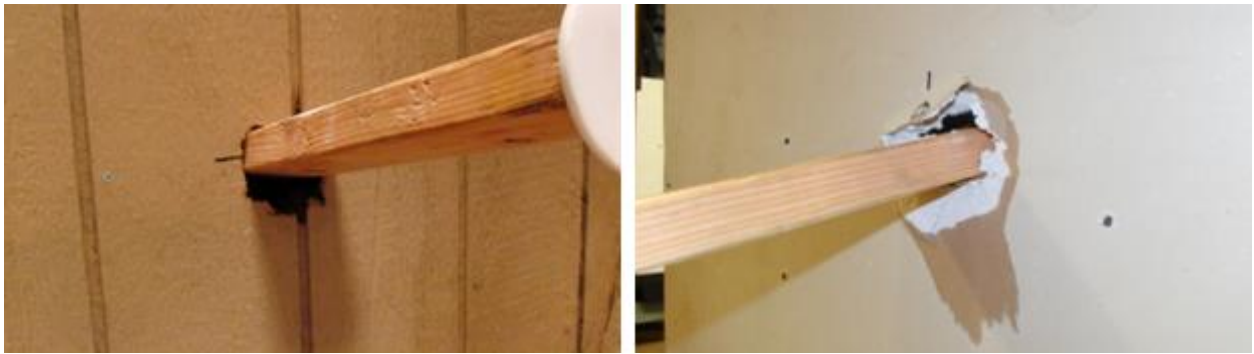
Figure 4-18: Panel M-A Typical Front (Left) and Rear (Right) Damage

This specimen was a derivative of the previous panel M-O with CFS studs at 16in on center instead of 24in and the use of a 5/8in fiberboard to simulate T1-11 plywood (Figure 4-17). The missile perforated the fiberboard and drywall with little resistance (Figure 4-18). Panel M-A is considered a failure based on all three tests (Table 4-9).

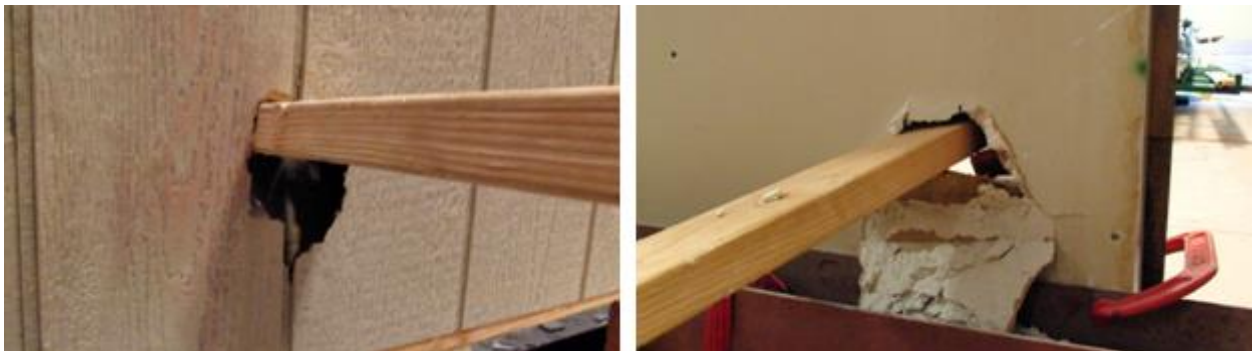
Figure 4-20: Panel M-B Typical Front (Left) and Rear (Right) Damage

This panel was identical to panel M-A but with CFS studs placed at 24in on center instead of 16in (Figure 4-19). The rearrangement of the studs did not affect the performance of the wall panel. The large missile perforated the fiberboard and drywall with little resistance (Figure 4-20). Panel M-B is considered a failure based on all three tests (Table 4-10).

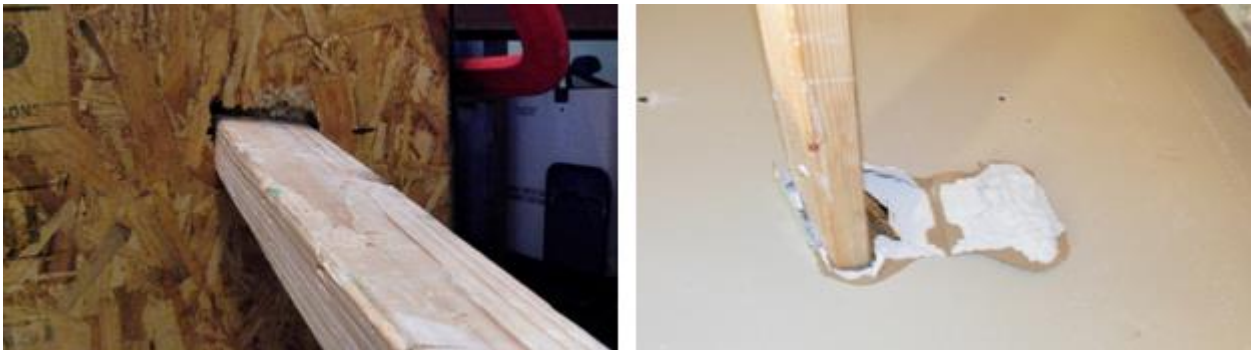
Figure 4-22: Panel M-C Typical Front (Left) and Rear (Right) Damage

Panel M-C consisted of exterior 3/4in oriented strand board (OSB), CFS studs at 16in on center, and an interior 1/2in drywall (Figure 4-21). The OSB did absorb a substantial amount of the energy but not enough to keep the missile from perforating all the layers (Figure 4-22). Based on all three tests, Panel M-C is considered a failure (Table 4-11).

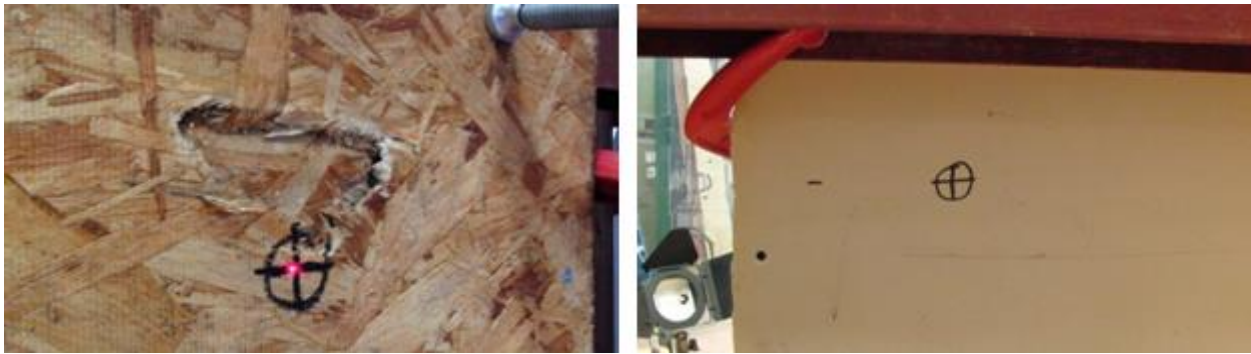
Figure 4-24: Panel M-D Typical Front (Left) and Rear (Right) Damage

This panel was identical to panel M-C but with the CFS studs placed 24in on center instead of 16in (Figure 4-23). The first three test missiles repurcussed from the exterior OSB layer (Figure 4-24). These results were not expected since panel M-C failed all three shots. An additional five test shots were conducted to verify these results. Seven of the total eight missile impacts passed the testing criteria; therefore, panel M-D is approved for class D large missile windborne debris impact resistance (Table 4-12). However, because of the failure of similar OSB wall panels with studs at 16in on center in panel M-C, 3/4in OSB wall panels are not recommended for use in safe room construction.

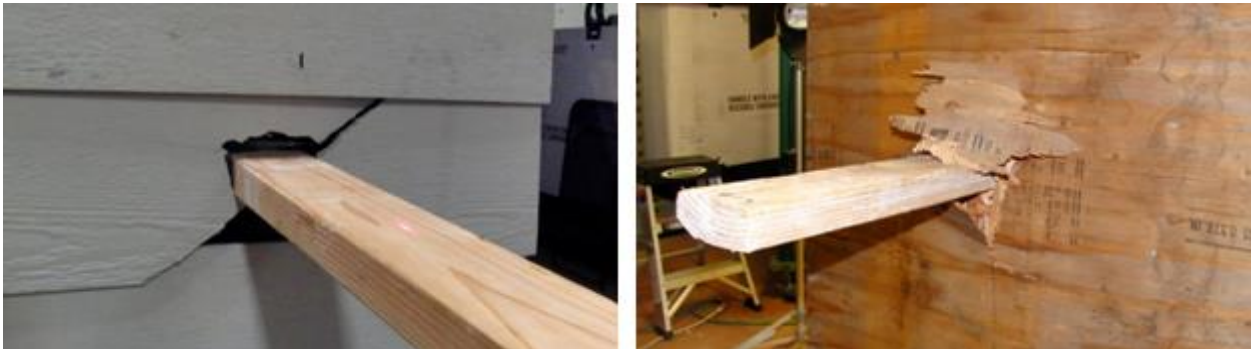
Figure 4-26: Panel M-E Typical Front (Left) and Rear (Right) Damage

Panel M-E consisted of exterior lap siding, CFS studs at 24in on center, and 5/8in T1-11 plywood attached to the interior face with self tapping screws (Figure 4-25). The flexibility of the T1-11 plywood and attaching hardware dissipated a substantial amount of the missile's energy. However, the panel was not strong enough to resist the missile from perforating the interior layer of the panel (Figure 4-26). Based on all three tests, Panel M-E is considered a failure (Table 4-13).

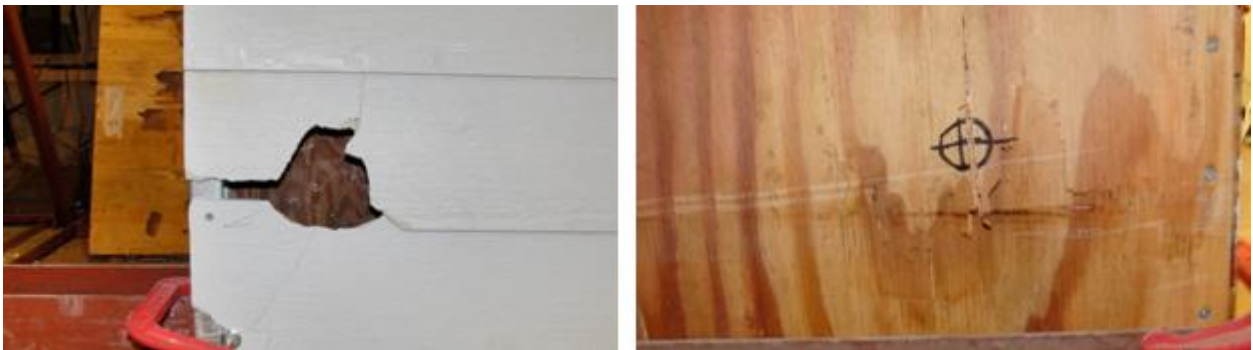
Figure 4-28: Panel M-F Front (Left) and Rear (Right) Damage for Bottom Left Test

This specimen was a derivative of the previous panel M-E with a layer of 3/4in plywood replacing the 5/8in T1-11 plywood (Figure 4-27). The missile shots in the bottom left corner and center of the specimen produced visible damage to the plywood layer (Figure 4-28). However, the splits were not large enough to be considered a failure. The third shot in the top right corner penetrated the plywood with a 7in long and 1/16in deep split. Since two of the test shots were a pass, the entire specimen is approved for class D large missile windborne debris impact resistance (Table 4-14).

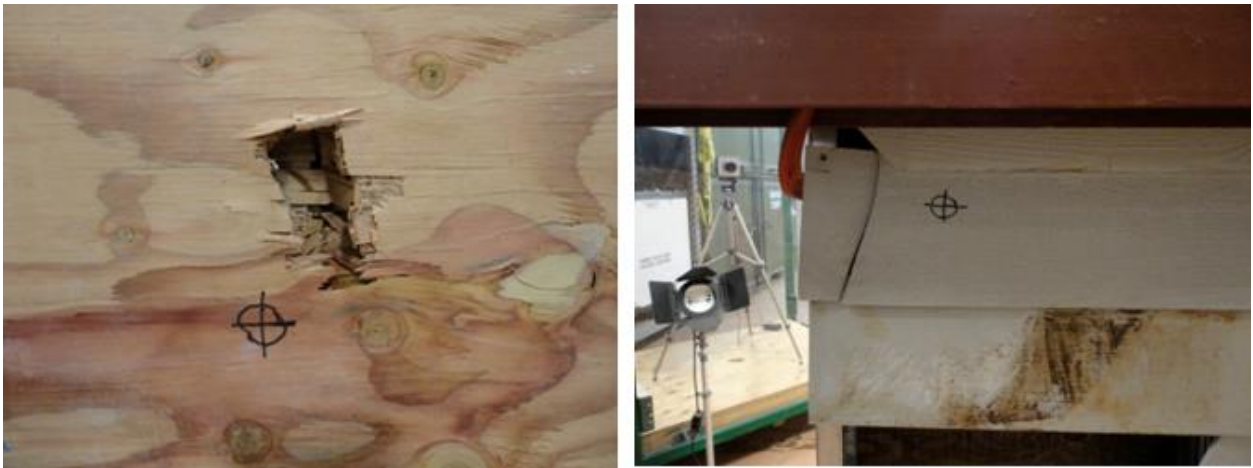
Panel M-F' is the same as Panel M-F but tested from the opposite side. The first shot penetrated the exterior layer and split the plywood substantially (Figure 4-29). It did not, however, perforate to the lap siding on the interior face. The following three missiles were repurcussed from the exterior face. Based on all four test shots, panel M-F is considered a pass and is approved for class D large missile windborne debris impact resistance (Table 4-15).

Figure 4-29: Panel M-F' Typical Front (Left) and Rear (Right) Damage

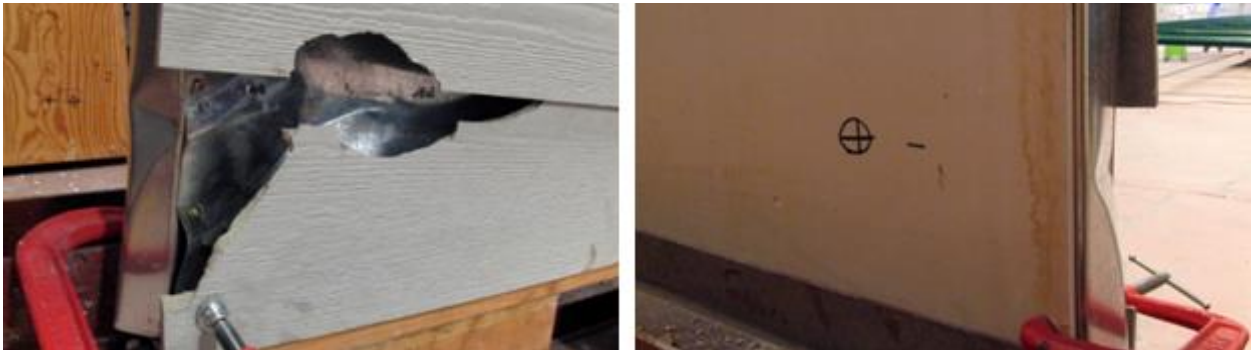
Figure 4-31: Panel M-G Typical Front (Left) and Rear (Right) Damage

Panel M-G consisted of exterior lap siding, 22gauge sheet metal, CFS studs at 24in on center, and 1/2in drywall (Figure 4-30). The missile perforated the lap siding but was repurcussed by the sheet metal panel (Figure 4-31). Based on all three tests, panel M-G is considered a pass and is approved for class D large missile windborne debris impact resistance (Table 4-16).

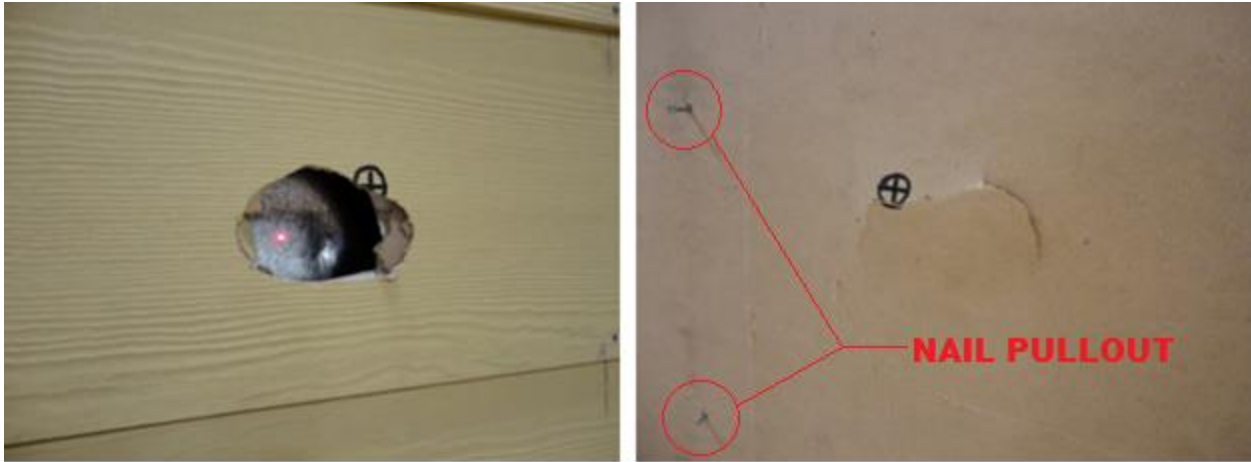
Figure 4-33: Panel 1 Typical Front (Left) and Rear (Right) Damage

Panel 1 consisted of Hardie Board lap siding, HomeWrap, wood studs at 16in on center, and CEMCO SureBoard (Figure 4-32). The missile perforated the lap siding and HomeWrap but was repurcussed by the SureBoard panel (Figure 4-33). The split that was inflicted on the exterior face of the SureBoard was superficial since the interior layer was still intact. Based on all three tests, panel 1 is considered a pass and is approved for class D large missile windborne debris impact resistance (Table 4-17). During the testing of panel 1, the nails on the interior face began to loosen and pop out of the SureBoard (Figure 4-33). It is recommended that screws be used on the interior face of the saferoom panels.

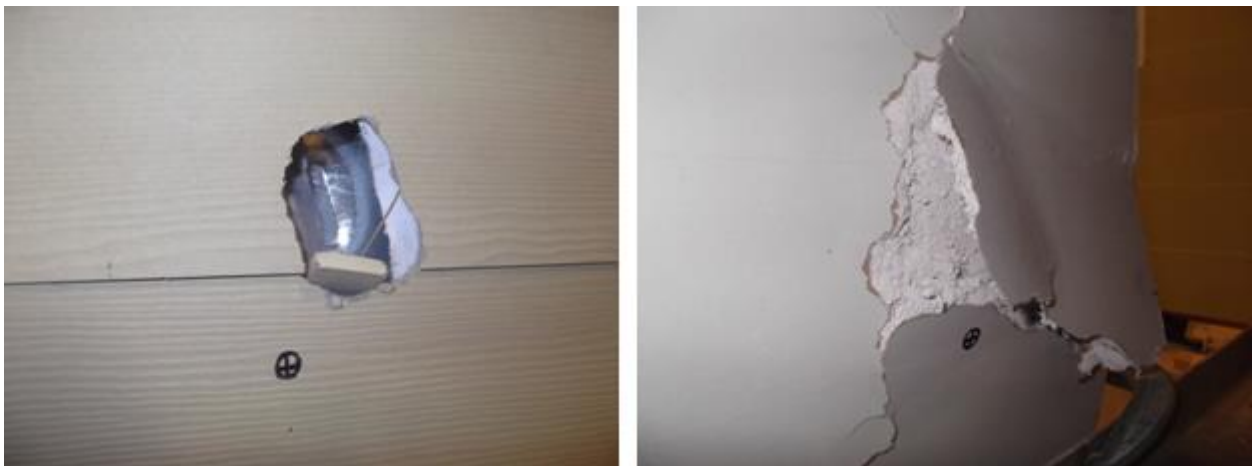
Figure 4-35: Panel 2 Typical Front (Left) and Rear (Right) Damage

Panel 2 consisted of Hardie Board lap siding, wood studs at 16in on center, 22gauge sheet metal, and 1/2in drywall (Figure 4-34). The missile perforated the lap siding but was repurcussed by the sheet metal panel (Figure 4-35). The force of the missile caused the drywall on the interior face to delaminate. The sheet metal in front of the drywall was still structurally intact so the damage was only superficial. Based on all three tests, panel 2 is considered a pass and is approved for class D large missile windborne debris impact resistance (Table 4-18).

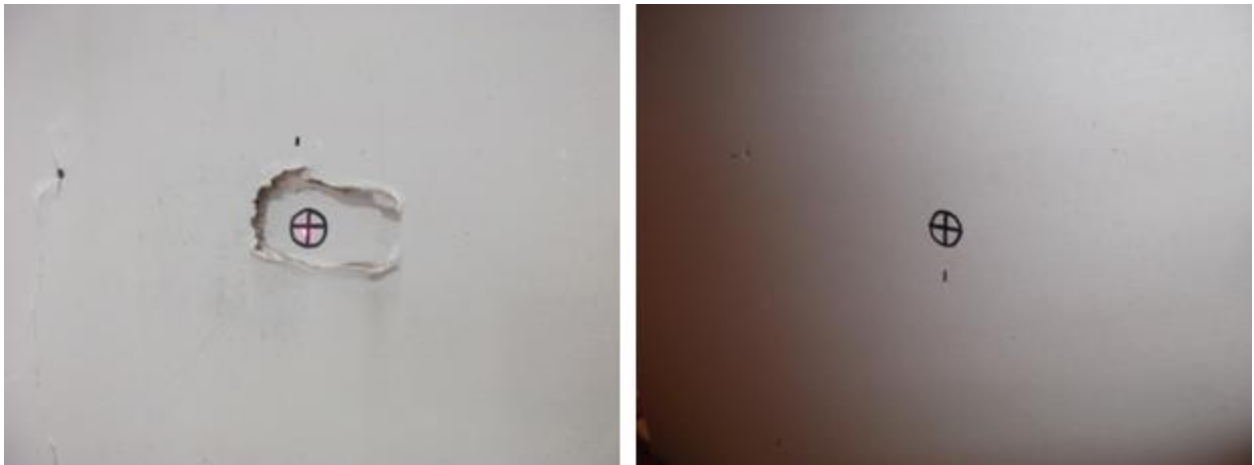
Figure 4-39: Panel 3' Typical Front (Left) and Rear (Right) Damage

Panel 3' is the same as panel 3 but tested from the opposite side (Figure 4-38). All three shots were repurcussed by the exterior layer of sheet metal. There was no damage done to the interior drywall layer (Figure 4-39). Based on all three test shots, panel 3' is considered a pass and is approved for class D large missile windborne debris impact resistance (Table 4-20).

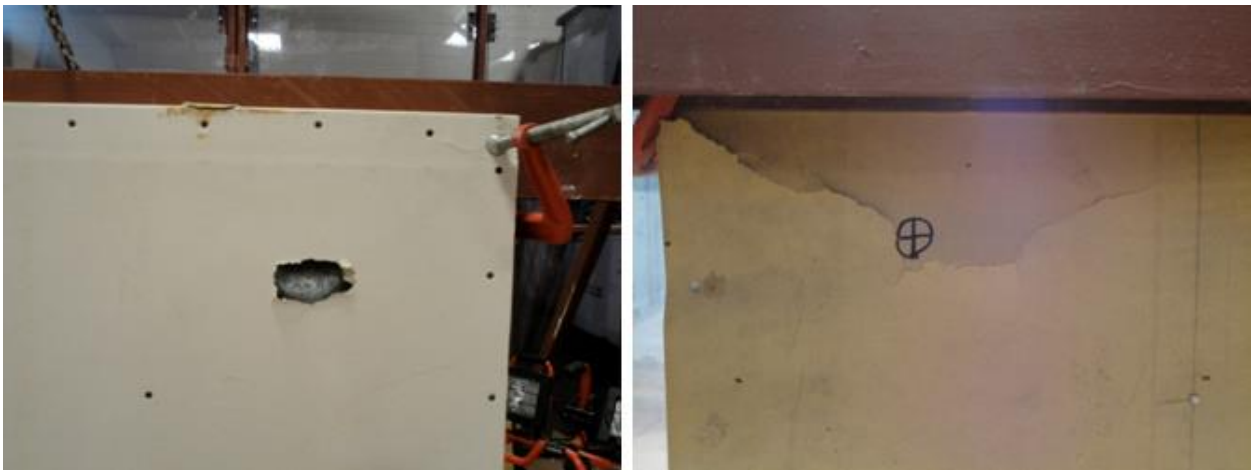
Figure 4-43: Panel 4' Typical Front (Left) and Rear (Right) Damage

Panel 4' is the same as panel 4 but tested from the opposite side (Figure 4-42). All three missiles perforated the exterior drywall layer but were repurcussed by the interior SureBoard. The force of the missile created a split on the interior face of the SureBoard (Figure 4-43). The sheet metal was still structurally intact so the damage was only superficial. Based on all three tests, panel 4' is considered a pass and is approved for class D large missile windborne debris impact resistance (Table 4-22).

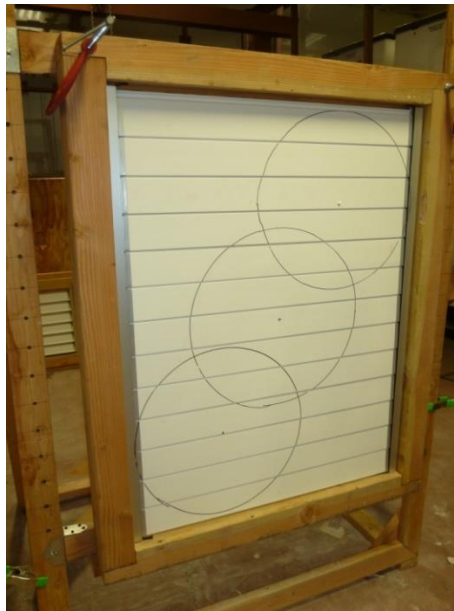
Figure 4-50: Medium Louver Sustained No Damage from Small Missiles
