**THE EFFECTS OF WINDBORNE DEBRIS
ON SAFEROOM WALL PANELS AND
FENESTRATION SYSTEMS**

**UNIVERSITY OF HAWAII
COLLEGE OF ENGINEERING**

Research Report UHM/CEE/12-10

February 2012

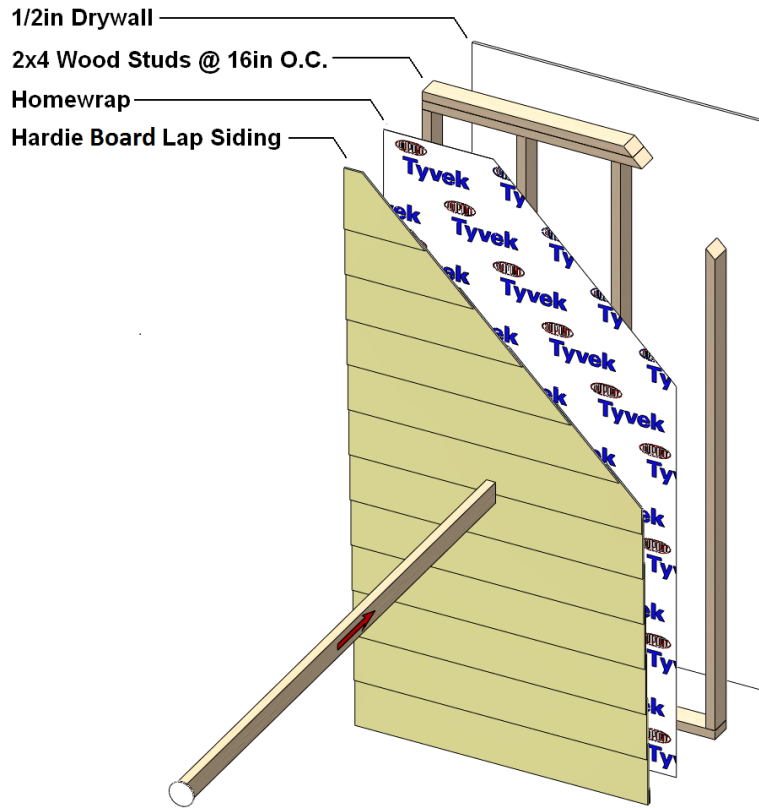
Figure 4-1: Panel O Exploded View

This wall specimen served as the control sample for the HLP 4'x8' panels as it represents typical residential exterior wall construction. The exploded view of the wall, and all similar figures, indicate the wall layers in the order in which they will be struck by the missile (Figure 4-1). The large missile perforated the lap siding, HomeWrap and drywall of Panel O with little resistance (Figure 4-2). Panel O is considered a failure based on all three tests (Table 4-1).

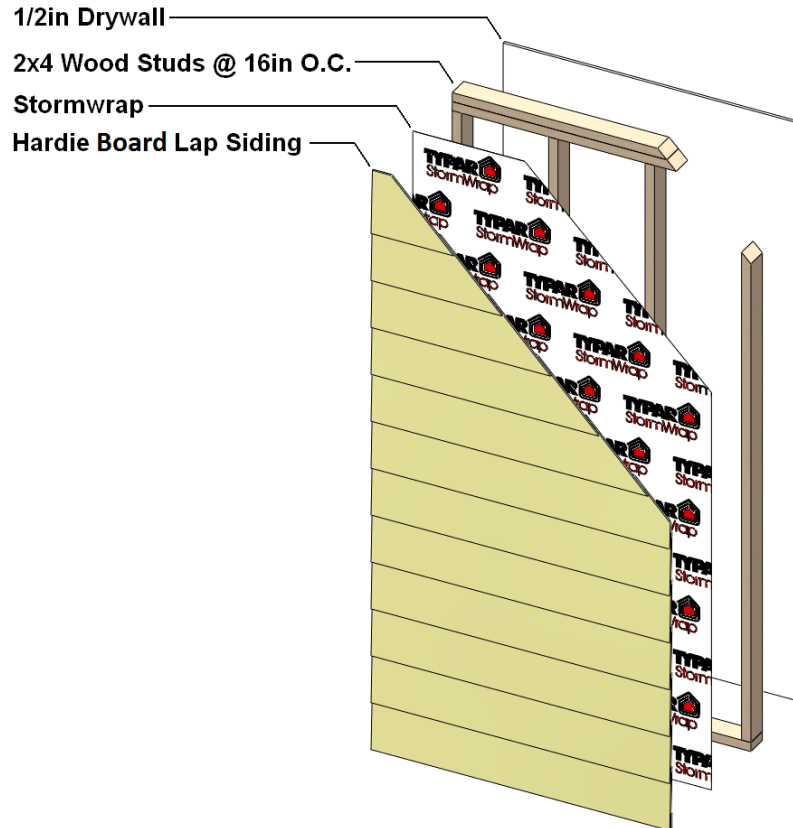
Figure 4-3: Panel A Exploded View

This specimen was a derivative of the previous panel O with a layer of StormWrap replacing the HomeWrap behind the lap siding (Figure 4-3). It was constructed with the expectation that it would provide better resistance to impact forces. It did not prove effective at preventing missile perforation (Figure 4-4). Panel A is considered a failure based on all three tests (Table 4-2).

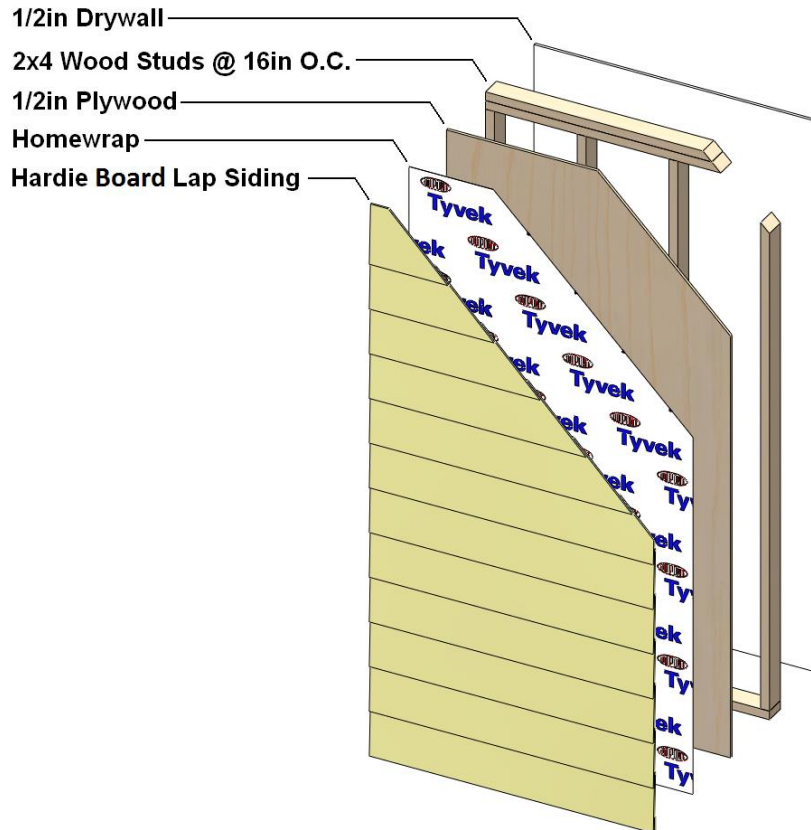
Figure 4-5: Panel B Exploded View

This specimen is based on Panel O but with the addition of a 1/2in plywood sheet behind the HomeWrap (Figure 4-5). For the first two tests, the missile perforated all layers of the panel (Figure 4-6). On the third test, the missile penetrated the interior cladding and caused a 5in long split in the drywall, but not wide enough to be considered a failure. However, since two of the three tests resulted in perforation, the specimen was considered a failure (Table 4-3).

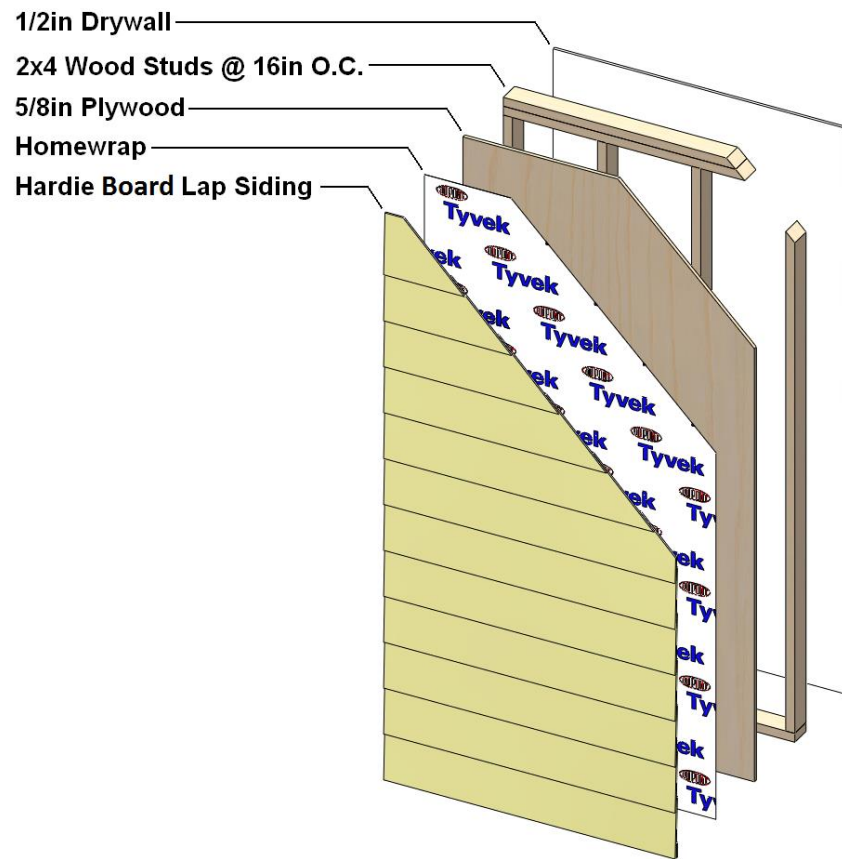
Figure 4-7: Panel C Exploded View

This panel was identical to panel B but with a 5/8in plywood sheet replacing the 1/2in plywood (Figure 4-7). The first test caused a 10in long and 1in wide split in the drywall. This was considered a failed test, however, the remaining two tests were considered a pass as no damage was done to the interior drywall (Figure 4-8). A fourth test was implemented on a new panel to compare with the original failure. This final test was a pass, therefore, the panel was approved for class D large missile windborne debris impact resistance (Table 4-4).

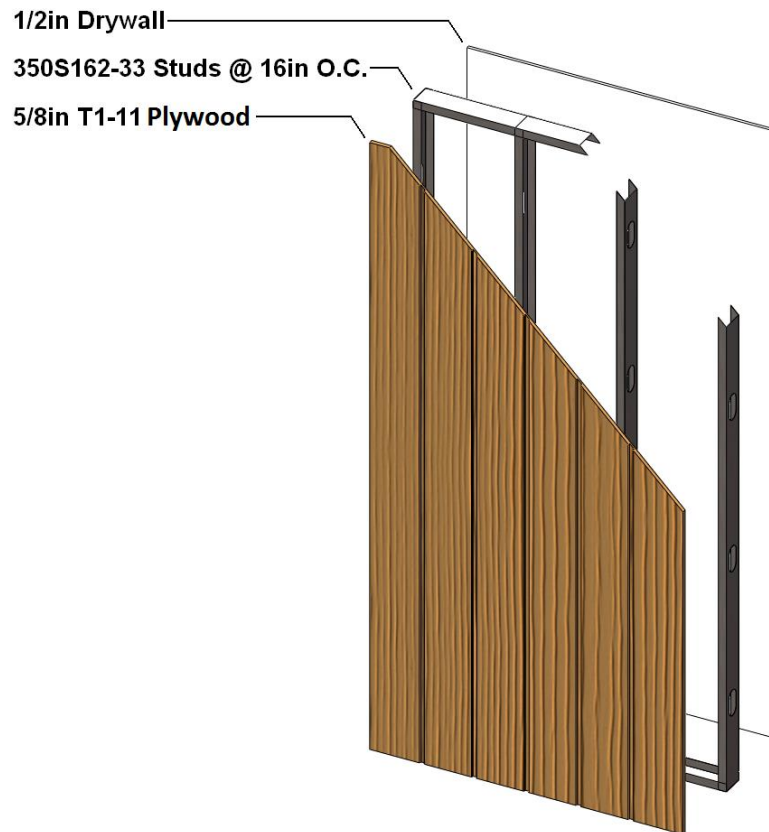
Figure 4-9: Panel O'

This wall specimen served as the control sample for the cold formed steel (CFS) 4'x8' panels (Figure 4-9). The large missile perforated the T1-11 exterior plywood and the drywall with little resistance (Figure 4-10). Panel O' is considered a failure based on all three tests (Table 4-5).

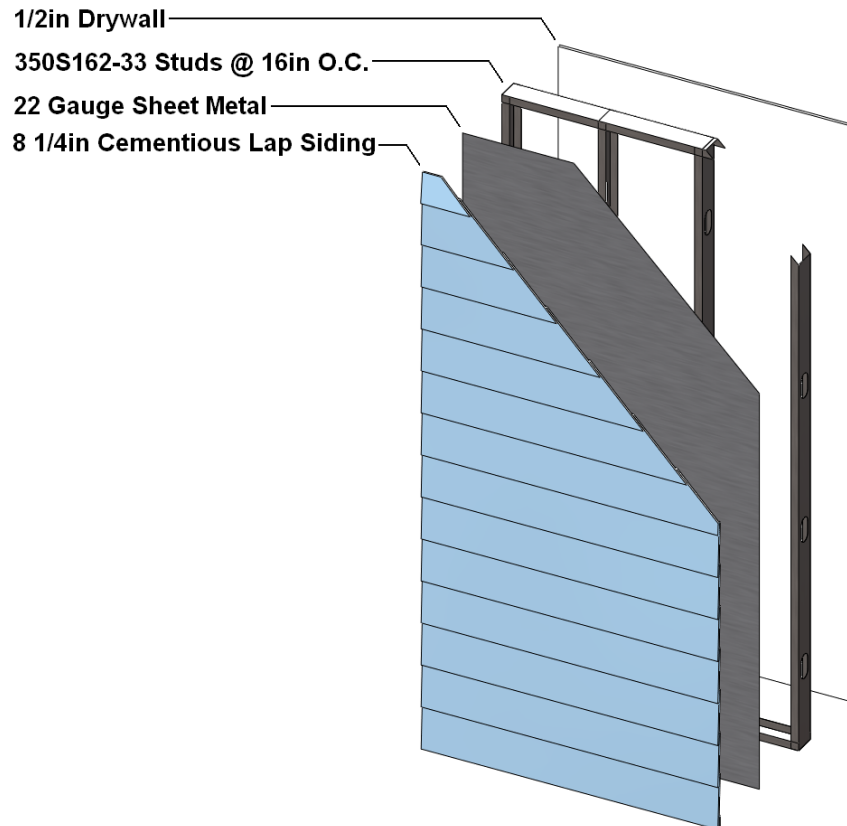
Figure 4-11: Panel G' Exploded View

Panel G' consisted of exterior Hardie Board siding, a 22gauge sheet metal layer screwed to the exterior of CFS studs placed at 16in on center, and an interior drywall layer (Figure 4-11). The addition of the sheet metal panel behind the lap siding greatly improved the performance of the wall system. During corner strikes, the CFS studs buckled under the impact load but there was no damage to the drywall (Figure 4-12). All three test shots were regarded with passing results (Table 4-6).

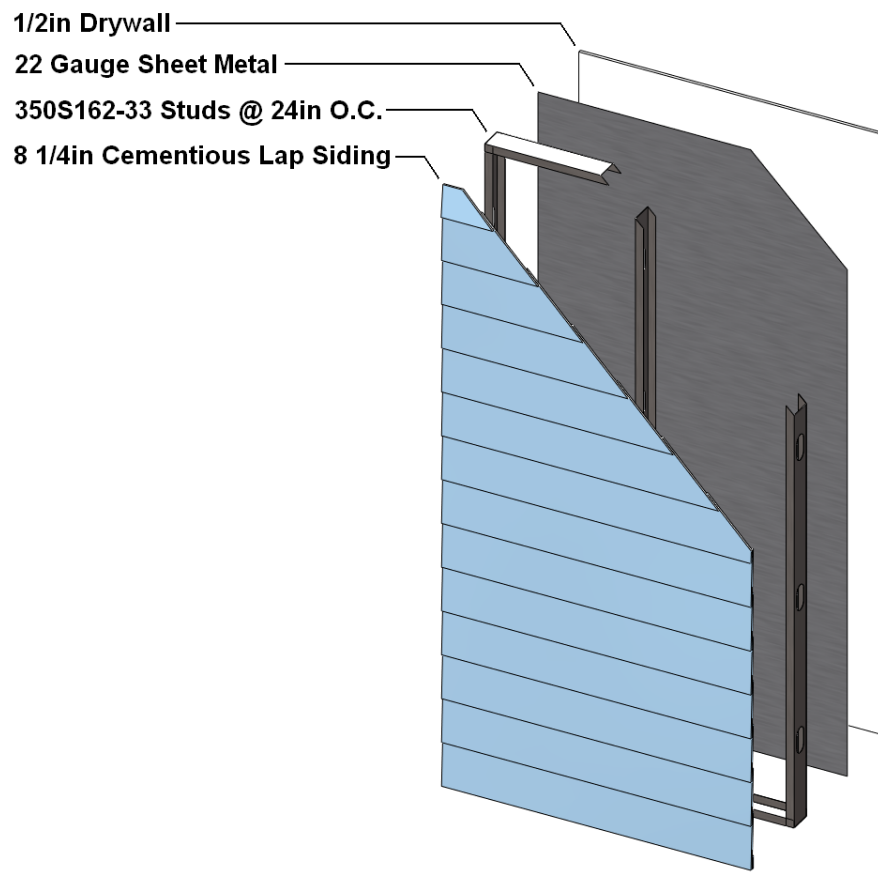
Figure 4-13: Panel H Exploded View

This specimen is similar to Panel G' but with CFS studs at 24in on center instead of 16in. The 22 gauge sheet metal was also fastened behind the studs with self-taping screws (Figure 4-13). All three shots caused the drywall to delaminate (Figure 4-14). However, the missile did repurcuss from the sheet metal without perforating it. There was no tear in this layer of the panel so the specimen was considered a pass (Table 4-7).

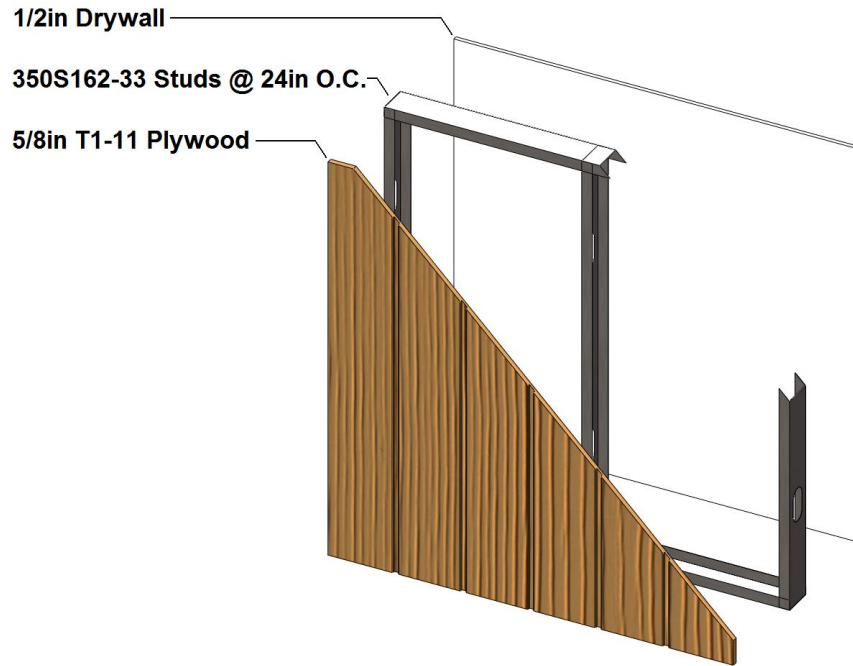
Figure 4-15: Panel Control M-O Exploded View

This wall specimen served as the control sample for the CFS 4'x4' panels (Figure 4-15). The large missile perforated the T1-11 plywood and drywall with little resistance (Figure 4-16). Panel M-O is considered a failure based on all three tests (Table 4-8).

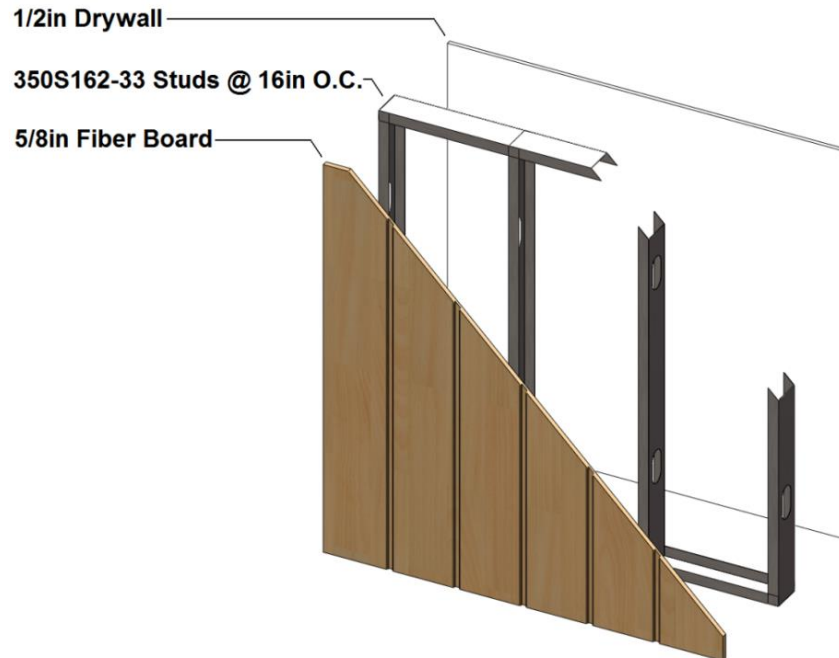
Figure 4-17: Panel M-A Exploded View

This specimen was a derivative of the previous panel M-O with CFS studs at 16in on center instead of 24in and the use of a 5/8in fiberboard to simulate T1-11 plywood (Figure 4-17). The missile perforated the fiberboard and drywall with little resistance (Figure 4-18). Panel M-A is considered a failure based on all three tests (Table 4-9).

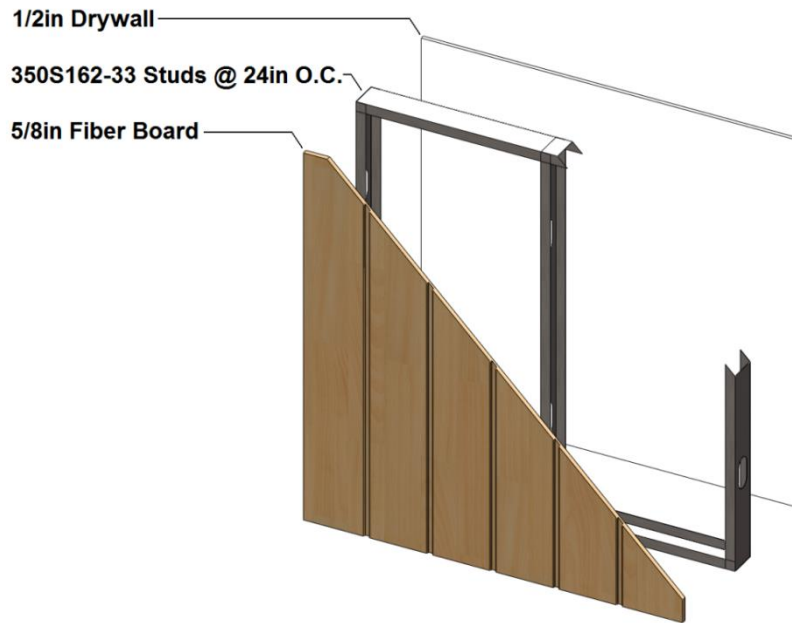
Figure 4-19: Panel M-B Exploded View

This panel was identical to panel M-A but with CFS studs placed at 24in on center instead of 16in (Figure 4-19). The rearrangement of the studs did not affect the performance of the wall panel. The large missile perforated the fiberboard and drywall with little resistance (Figure 4-20). Panel M-B is considered a failure based on all three tests (Table 4-10).

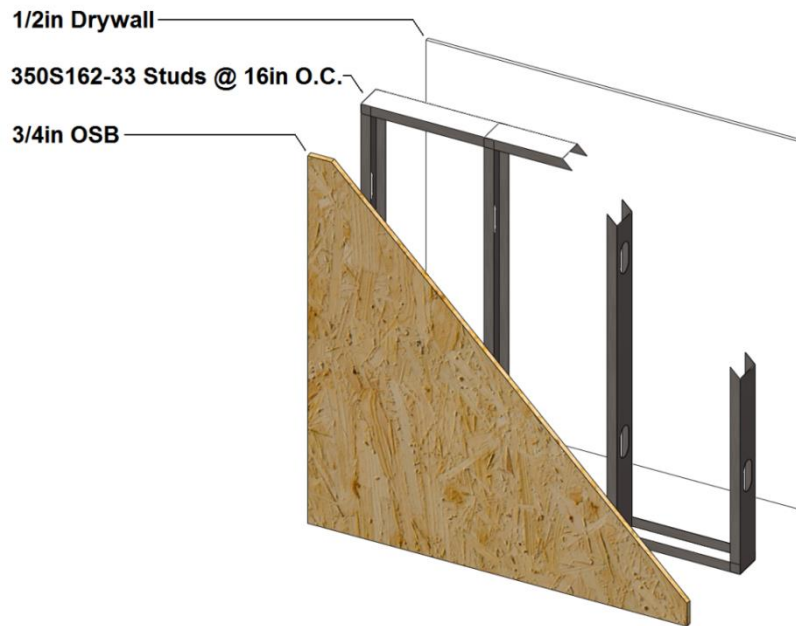
Figure 4-21: Panel M-C Exploded View

Panel M-C consisted of exterior 3/4in oriented strand board (OSB), CFS studs at 16in on center, and an interior 1/2in drywall (Figure 4-21). The OSB did absorb a substantial amount of the energy but not enough to keep the missile from perforating all the layers (Figure 4-22). Based on all three tests, Panel M-C is considered a failure (Table 4-11).

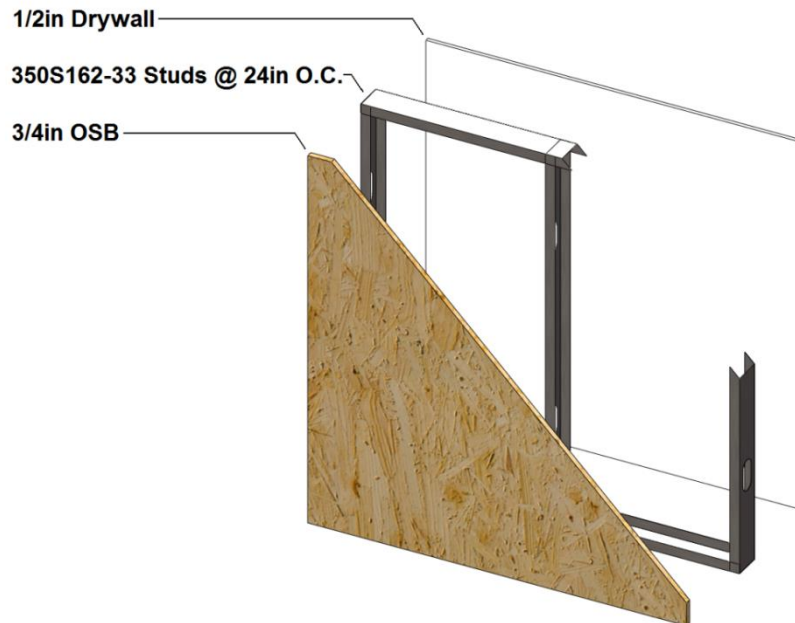
Figure 4-23: Panel M-D Exploded View

This panel was identical to panel M-C but with the CFS studs placed 24in on center instead of 16in (Figure 4-23). The first three test missiles repurcussed from the exterior OSB layer (Figure 4-24). These results were not expected since panel M-C failed all three shots. An additional five test shots were conducted to verify these results. Seven of the total eight missile impacts passed the testing criteria; therefore, panel M-D is approved for class D large missile windborne debris impact resistance (Table 4-12). However, because of the failure of similar OSB wall panels with studs at 16in on center in panel M-C, 3/4in OSB wall panels are not recommended for use in safe room construction.

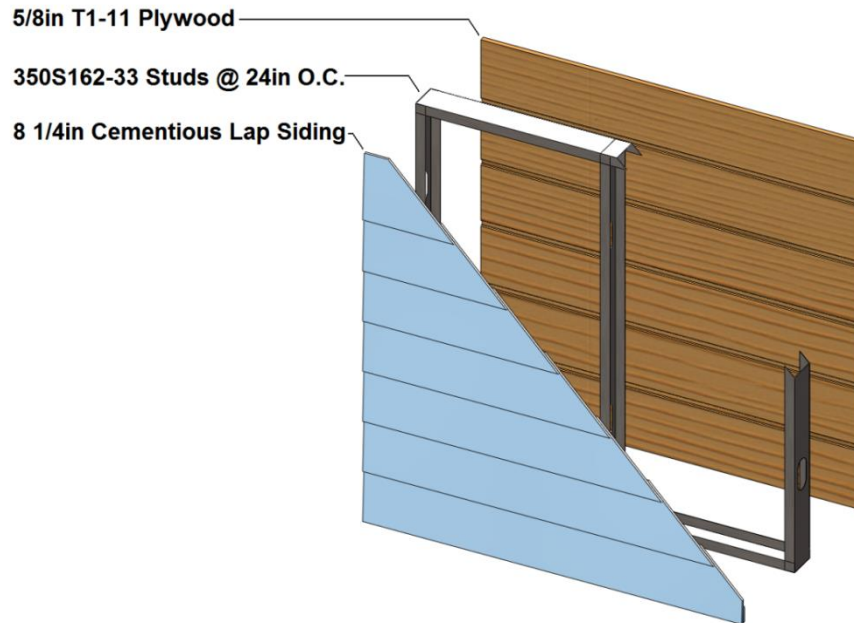
Figure 4-25: Panel M-E Exploded View

Panel M-E consisted of exterior lap siding, CFS studs at 24in on center, and 5/8in T1-11 plywood attached to the interior face with self tapping screws (Figure 4-25). The flexibility of the T1-11 plywood and attaching hardware dissipated a substantial amount of the missile's energy. However, the panel was not strong enough to resist the missile from perforating the interior layer of the panel (Figure 4-26). Based on all three tests, Panel M-E is considered a failure (Table 4-13).

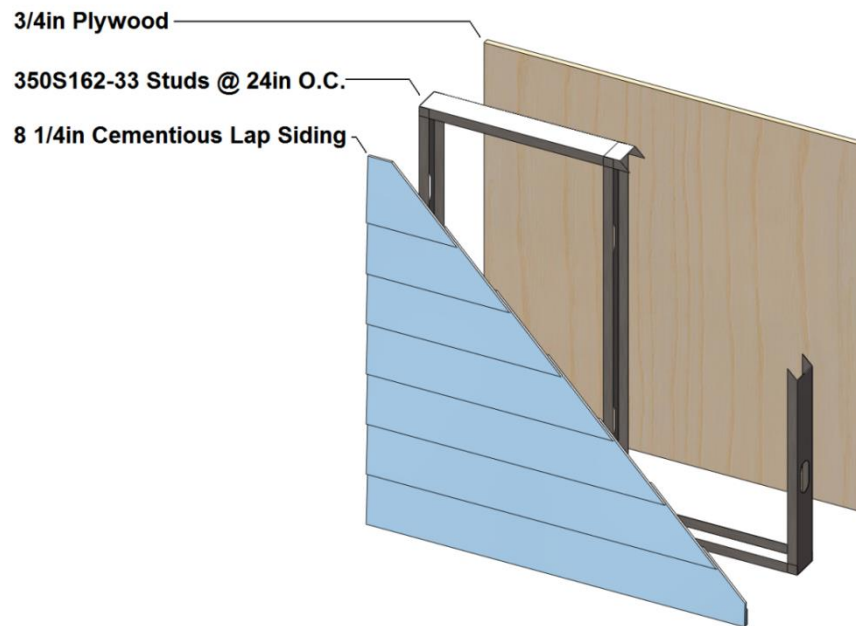
Figure 4-27: Panel M-F Exploded View

This specimen was a derivative of the previous panel M-E with a layer of 3/4in plywood replacing the 5/8in T1-11 plywood (Figure 4-27). The missile shots in the bottom left corner and center of the specimen produced visible damage to the plywood layer (Figure 4-28). However, the splits were not large enough to be considered a failure. The third shot in the top right corner penetrated the plywood with a 7in long and 1/16in deep split. Since two of the test shots were a pass, the entire specimen is approved for class D large missile windborne debris impact resistance (Table 4-14).

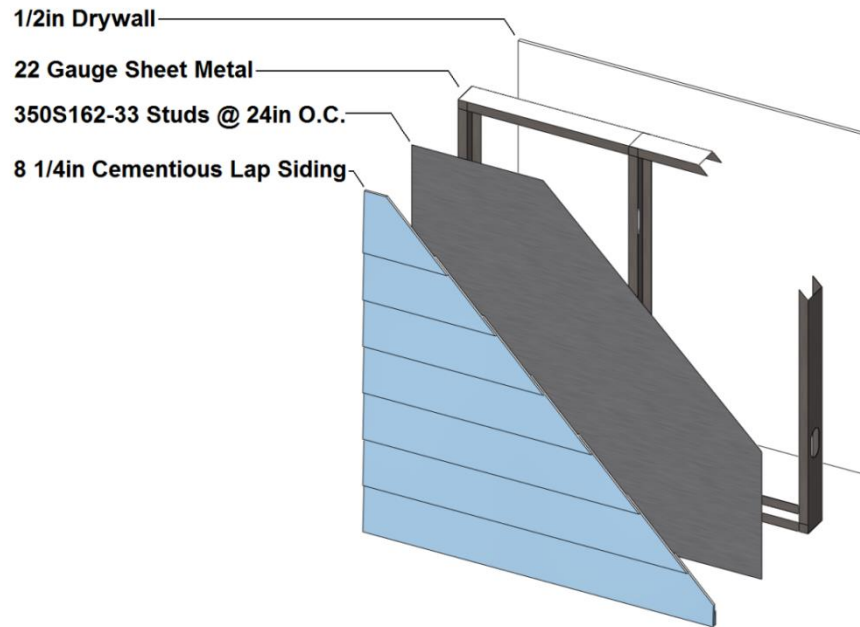
Figure 4-30: Panel M-G Exploded View

Panel M-G consisted of exterior lap siding, 22gauge sheet metal, CFS studs at 24in on center, and 1/2in drywall (Figure 4-30). The missile perforated the lap siding but was repurcussed by the sheet metal panel (Figure 4-31). Based on all three tests, panel M-G is considered a pass and is approved for class D large missile windborne debris impact resistance (Table 4-16).

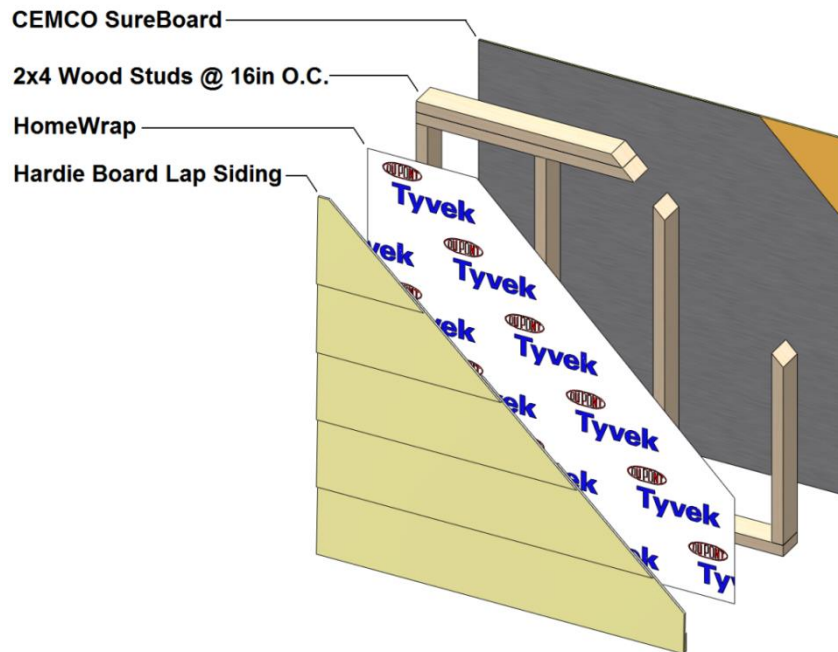
Figure 4-32: Panel 1 Exploded View

Panel 1 consisted of Hardie Board lap siding, HomeWrap, wood studs at 16in on center, and CEMCO SureBoard (Figure 4-32). The missile perforated the lap siding and HomeWrap but was repurcussed by the SureBoard panel (Figure 4-33). The split that was inflicted on the exterior face of the SureBoard was superficial since the interior layer was still intact. Based on all three tests, panel 1 is considered a pass and is approved for class D large missile windborne debris impact resistance (Table 4-17). During the testing of panel 1, the nails on the interior face began to loosen and pop out of the SureBoard (Figure 4-33). It is recommended that screws be used on the interior face of the saferoom panels.

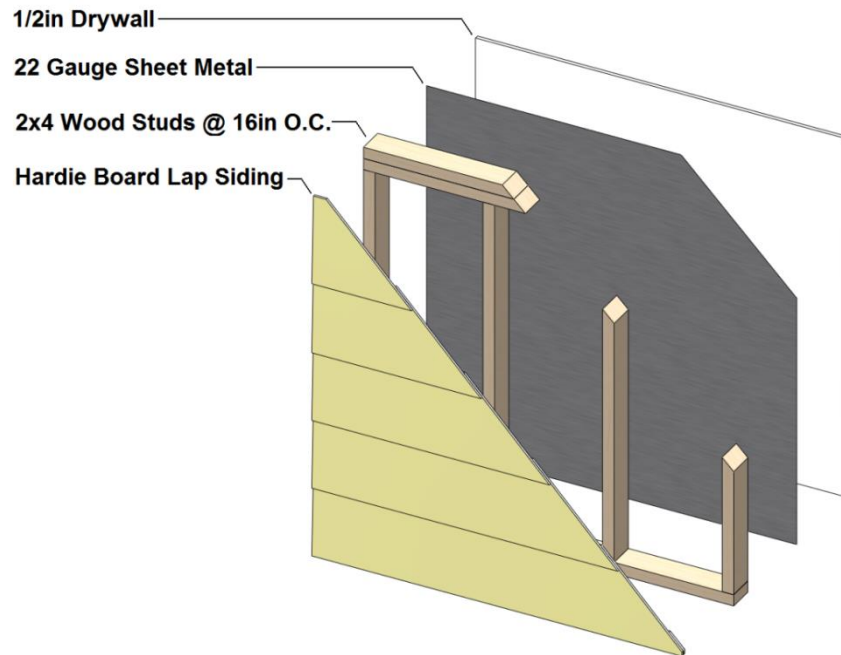
Figure 4-34: Panel 2 Exploded View

Panel 2 consisted of Hardie Board lap siding, wood studs at 16in on center, 22gauge sheet metal, and 1/2in drywall (Figure 4-34). The missile perforated the lap siding but was repurcussed by the sheet metal panel (Figure 4-35). The force of the missile caused the drywall on the interior face to delaminate. The sheet metal in front of the drywall was still structurally intact so the damage was only superficial. Based on all three tests, panel 2 is considered a pass and is approved for class D large missile windborne debris impact resistance (Table 4-18).

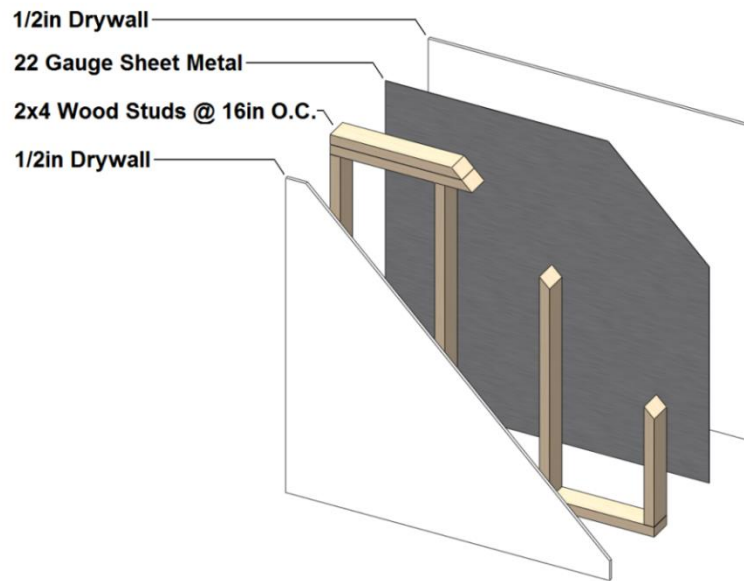
Figure 4-36: Panel 3 Exploded View

Panel 3 represented a true interior wall and consisted of 1/2in drywall, wood studs at 16in on center, 22gauge sheet metal, and 1/2in drywall (Figure 4-36). The missile perforated the exterior drywall but was repurcussed by the sheet metal panel (Figure 4-37). The force of the missile caused the drywall on the interior face to delaminate. The sheet metal in front of the drywall was still structurally intact so the damage was only superficial. Based on all three tests, panel 3 is considered a pass and is approved for class D large missile windborne debris impact resistance (Table 4-19).

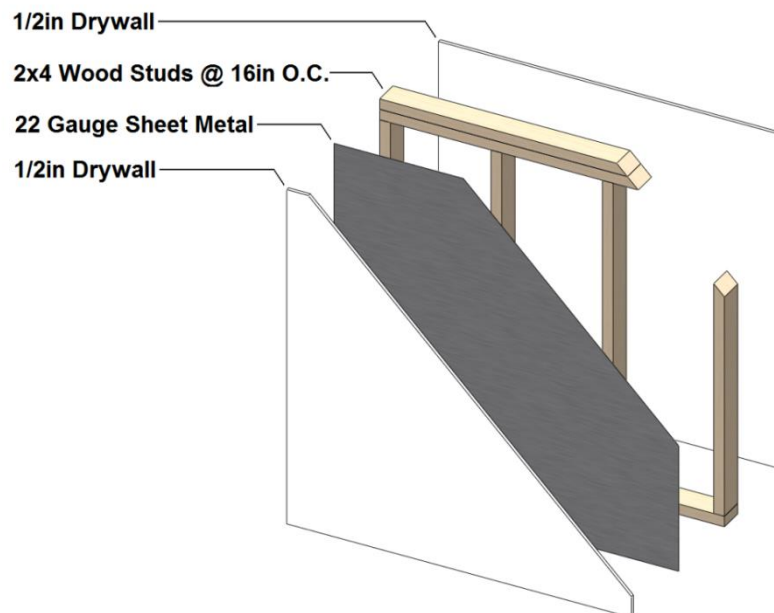
Figure 4-38: Panel 3' Exploded View

Panel 3' is the same as panel 3 but tested from the opposite side (Figure 4-38). All three shots were repurcussed by the exterior layer of sheet metal. There was no damage done to the interior drywall layer (Figure 4-39). Based on all three test shots, panel 3' is considered a pass and is approved for class D large missile windborne debris impact resistance (Table 4-20).

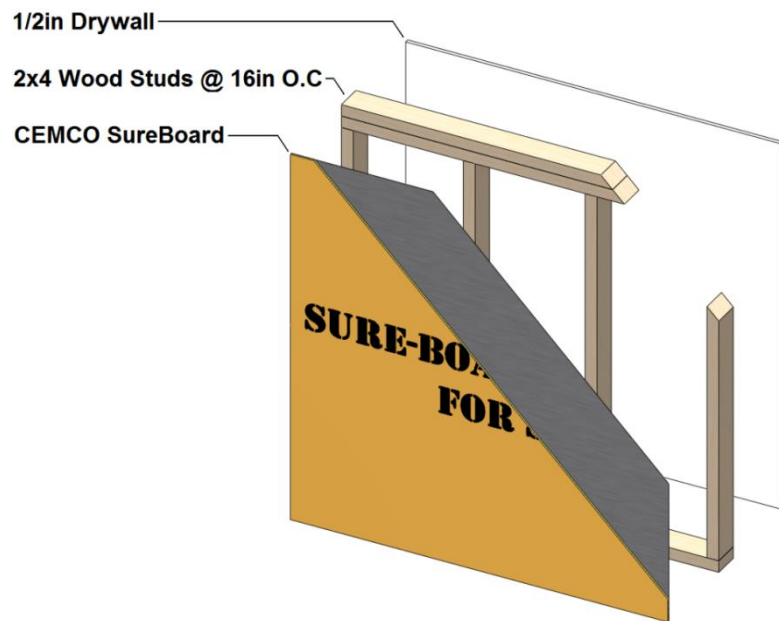
Figure 4-40: Panel 4 Exploded View

Panel 4 consisted of CEMCO SureBoard, wood studs at 16in on center, and 1/2in drywall (Figure 4-40). All three missiles were repurcussed by the SureBoard on the exterior face. There was no damage done to the interior drywall (Figure 4-41). Based on all three tests, panel 4 is considered a pass and is approved for class D large missile windborne debris impact resistance (Table 4-21).

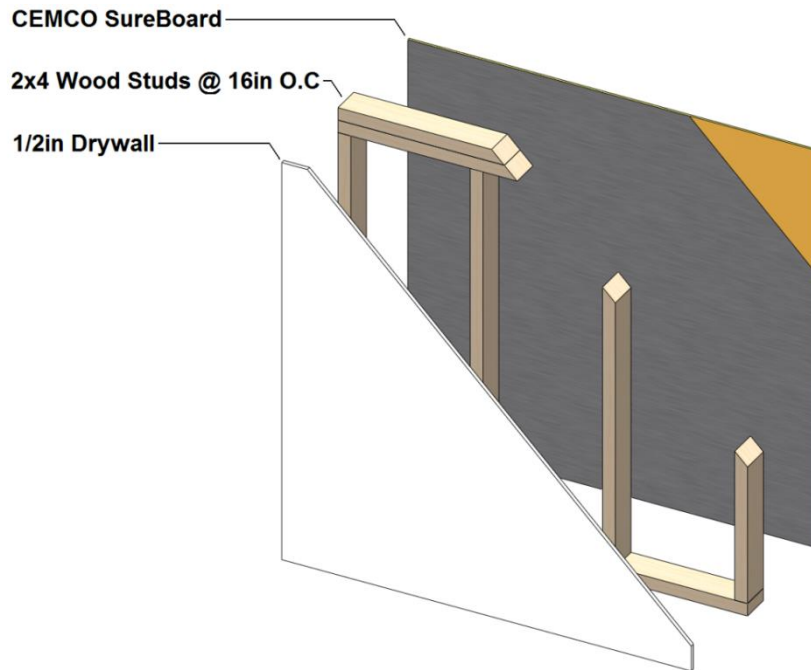
Figure 4-42: Panel 4' Exploded View

Panel 4' is the same as panel 4 but tested from the opposite side (Figure 4-42). All three missiles perforated the exterior drywall layer but were repurcussed by the interior SureBoard. The force of the missile created a split on the interior face of the SureBoard (Figure 4-43). The sheet metal was still structurally intact so the damage was only superficial. Based on all three tests, panel 4' is considered a pass and is approved for class D large missile windborne debris impact resistance (Table 4-22).

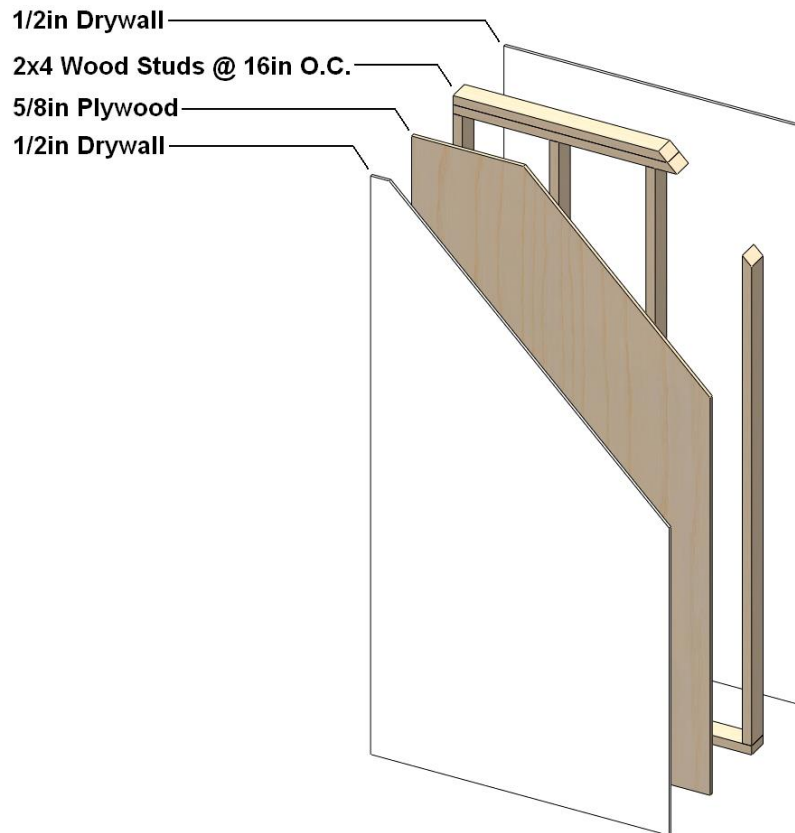
Figure 4-44: Panel 5 Exploded View

Panel 5 consisted of 1/2in drywall, 5/8in plywood, wood studs at 16in on center, and 1/2in drywall (Figure 4-44). The specimen was tested twice, and both missiles perforated the exterior and interior layers (Figure 4-45). Based on both tests, Panel 5 is considered a failure (Table 4-23).

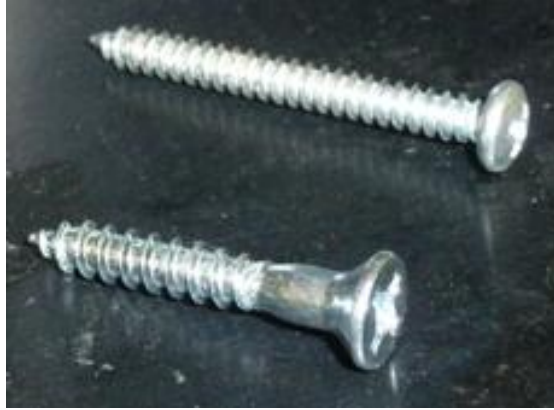
During preliminary trial tests, it was determined that the original #8 screws securing the inner aluminum frame to the outer wood frame sheared off. This would not classify as a passing test, therefore, all securing screws were replaced with 1.25in long #10 wood screws prior to testing of all louvers reported here (Figure 4-46).

Figure 4-46: Screw Replacement for Louver Assemblies (Upper #8 screw replaced by lower #10 wood screw)

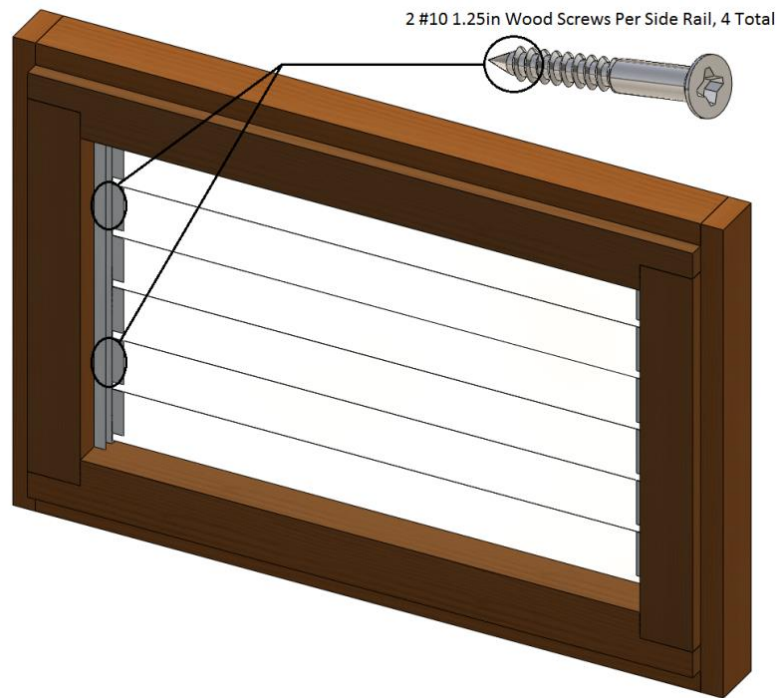
Figure 4-47: Small Louver Fenestration Assembly

This fenestration assembly was constructed of 6 vinyl blades attached to an aluminum frame measuring 36in wide by 22in high (Figure 4-47). The small missile shot did no apparent damage to the louvers. The 4ft – 4.5lb missile did significant damage to the aluminum clips that held the blades to the frame (Figure 4-48). Based on the two shots conducted, the openings between the deformed louvers would have allowed a 3in diameter sphere to pass through. A third test was not conducted since the damage to the assembly from the first two shots was so significant that it would have affected the outcome of the top right impact location. This specimen is deemed a failure and is not approved for class C large missile windborne debris clearance (Table 4-25).

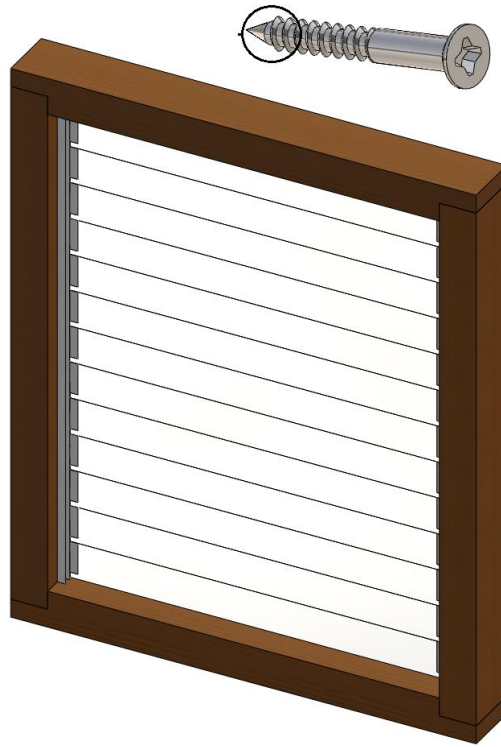
Figure 4-49: Medium Louver Fenestration Assembly

This fenestration assembly was constructed of 13 vinyl blades attached to an aluminum frame measuring 36in wide by 46in high (Figure 4-49). The small missile shot did no apparent damage to the louvers (Figure 4-50). The vinyl material was examined and there were no permanent marks left on the surface. Based on the three shots conducted for the class A small missile test, the panel is considered a pass (Table 4-26). The louvers behaved in a very elastic manner when tested in the center with the 4ft large missile. The projectile struck the target and recoiled back leaving very little inelastic damage to the specimen. The lower left and upper right shots, however, bent several of the aluminum clips and even broke one of the louvers. Since two of the three trials did significant damage, the specimen is considered a failure for the class C large missile test (Table 4-26).

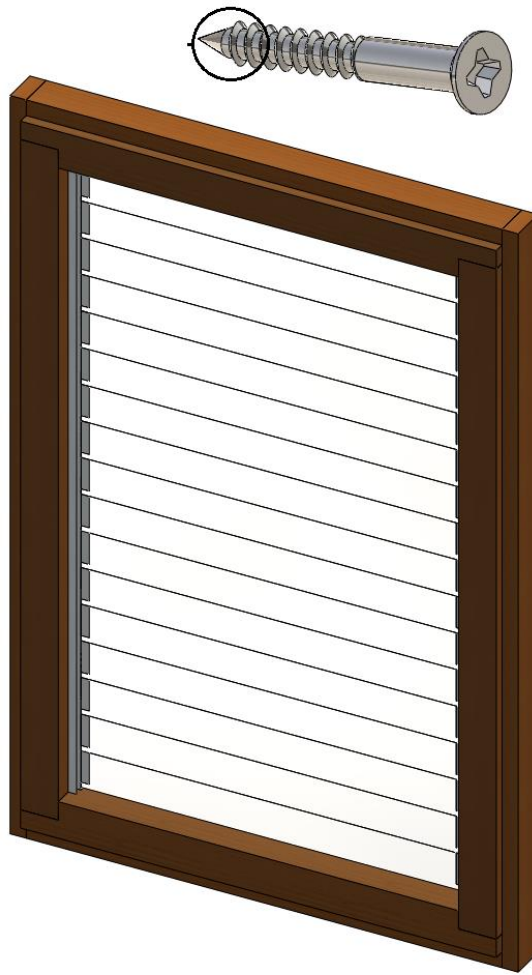
Figure 4-52: Large Louver Fenestration Assembly

This fenestration assembly was constructed of 17 vinyl blades attached to an aluminum frame measuring 36in wide by 63in high (Figure 4-52). The small missile shot did no apparent damage to the louvers. The 4ft – 4.5lb missile was rejected at the center position as the flexible blades absorbed most of the energy. At the bottom left, there was inelastic damage done to the aluminum clips that held the vinyl louvers in place. At the top right, the missile broke through one of the panels (Figure 4-53). Since two of the three trials did significant damage, the specimen is considered a failure for the class C large missile test (Table 4-27).

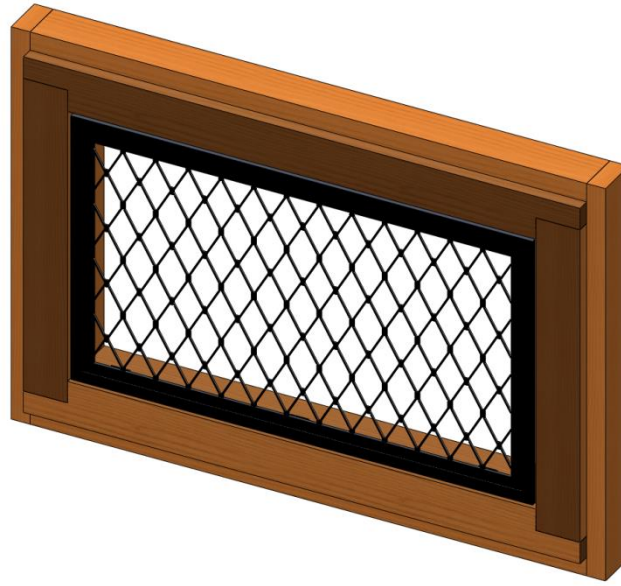
Figure 4-55: Small Window Protection Screen

This small protection screen was made of an extruded aluminum mesh connected to an aluminum frame via pop rivets (Figure 4-55). The screen was installed in an opening measuring 36in wide by 22in high. This security screen and all subsequent security screens were fastened to the wood frame using 1in long #5 lag screws. For the center shot, the 4ft – 4.5lb missile deflected the screen 3.8in dynamically. At the bottom right, the screen deflected 5in. At the top left, the pop rivets that held the screen to the frame broke free which resulted in an excessive deflection (Figure 4-56). The test results can be seen in Table 4-29.

Had the three tests been performed on three separate specimens, it is predicted that all three tests would pass.

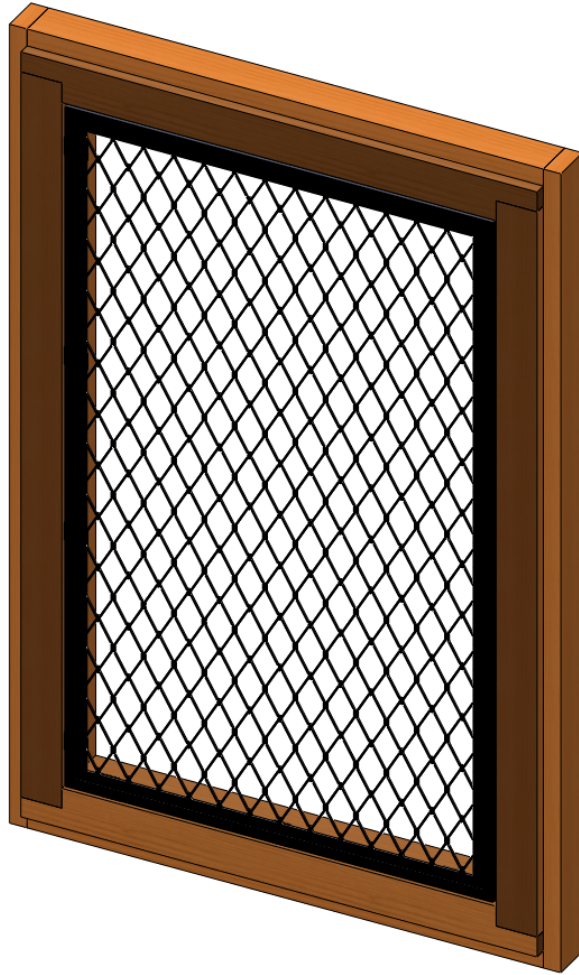
Figure 4-57: Large Window Protection Screen

This large protection screen was made of an extruded aluminum mesh connected to an aluminum frame via pop rivets (Figure 4-57). The screen was installed in an opening measuring 36in wide by 63in high. For the center shot, the 4ft missile deflected the screen 4.4in dynamically. At the bottom right, the screen deflected 4.6in. At the top left, the screen deflected 3.0in (Figure 4-58). The test results can be seen in Table 4-30.

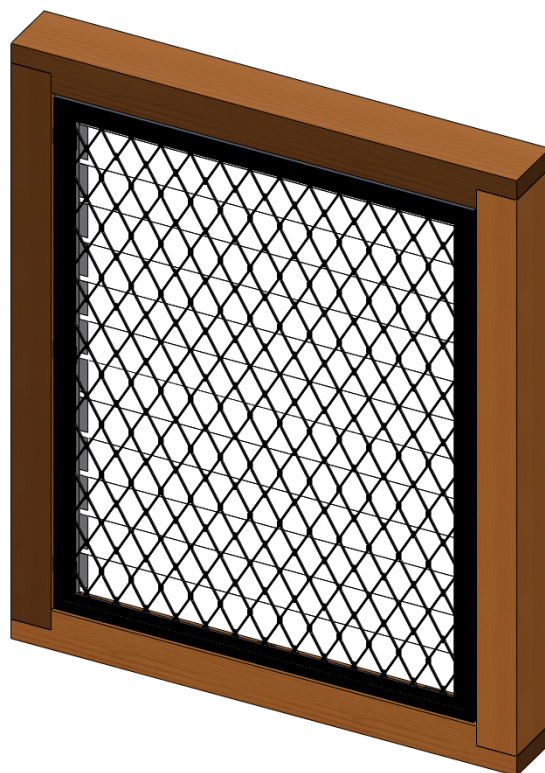
Figure 4-59: Dual System

This system consisted of a protection screen installed in front of a PVC louver assembly (Figure 4-59). The medium size protection screen was made of an extruded aluminum mesh connected to an aluminum frame via pop rivets. The medium size fenestration assembly was constructed of 13 vinyl blades attached to an outer aluminum frame. The system was installed in an opening measuring 36in wide by 46in high. This assembly was subjected to a single center shot using a level D missile. For the center shot, the 8ft missile deflected the system 5.6in dynamically (Figure 4-60). The missile was repurcussed with no significant damage to the screen or louver elements. The test results can be seen in Table 4-31.
